A Theory for the Collapse of the World Trade Center Towers

by Christian J. Simensen, SINTEF

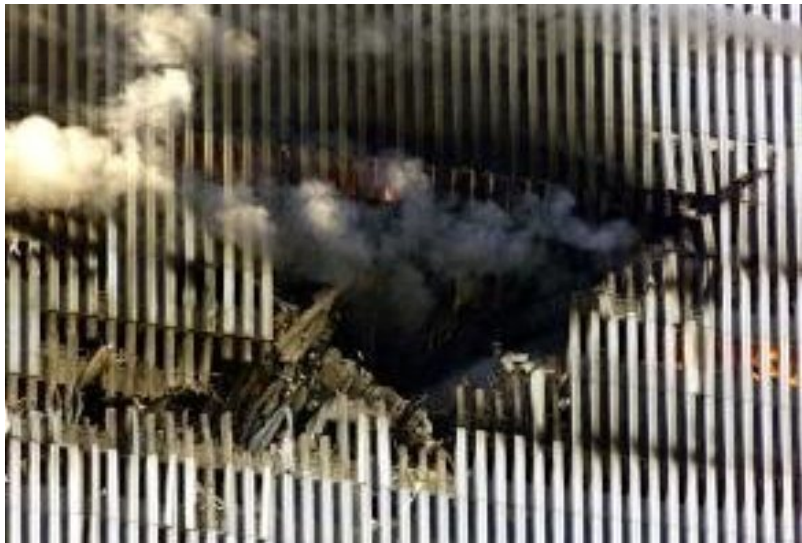
It is evident that the airplanes went through the outer wall cutting the wall like a Samurai sword and pushing that section of the wall with them (figure 4⁸). This will reduce the speed approximately 50-100 km/hour. Both buildings were a construction of thick steel bars, 3-6 cm in diameter, which made a three dimensional cubic like net of vertical and horizontal rods (illustrated on figure 5). These sets of bars were covered by floors, ceilings and walls. The airplanes went through several series of steel bars, each time the speed was reduced, and more materials were pushed in front and to the sides of the crashing airplanes (figure 5). As the speed fell, the steel bars must have been dragged along, and ceilings must have collapsed. The airplanes must have been cut to pieces by the array of steel bars and probably came to a standstill somewhere in the middle of the building. The airplanes must have taken with them 10-15 series of steel bars and walls which must have piled up in front of them, and sections of the ceilings would probably have fallen on top of the fractures airplanes (figure 6). Thus the airplanes were almost buried in walls and ceilings which were mainly made of gypsum with a low thermal conductivity (see appendix).

Figure 4: Picture of WTC 1 immediately after the airplane had cut its way into the building⁸. The contour of the airplane is visible.

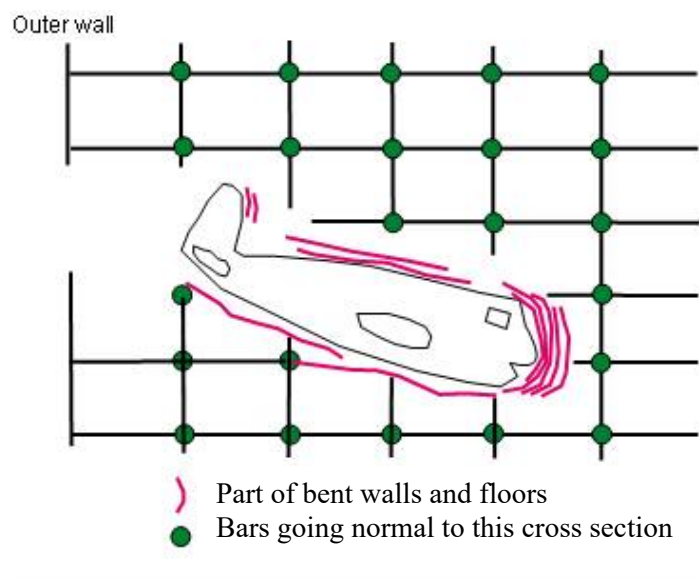
Figure 5: Cross section of the air plane and part of the Twin Tower shortly after the airplane hits the outer wall. Only the array of steel bars is shown. Parts of the floor and walls are dragged along with the airplane.

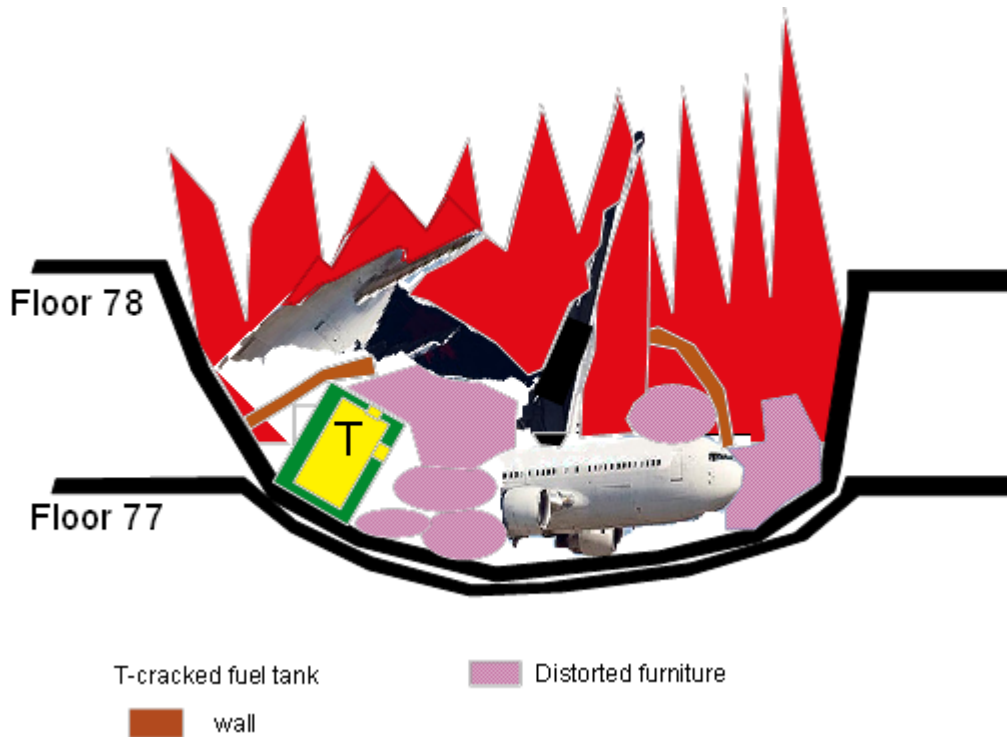
What happened to the airplanes? They were probably cut into long, rectangular blocks by the high strength network of rods. These rods probably also sliced the fuel tanks situated in the wings in different heights. The result was that the sectioned tanks were burning with almost constant rate after the crash (figure 6).

Near the centre of the building was the fracture airplane with a total net weight of 87 tonnes, people and furniture. All were heated by the fuel (figure 6). This hot zone had almost one common temperature due to the high heat conductivity of the fragmented aluminium parts (see appendix). The weight of the aluminium in each aircraft was of the order 30 tonnes, while the remainder consisted of steel, polymers and carbon fibre materials. The hot zone was surrounded mainly by piled-up walls and floors mostly made of insulating materials which acted as a thermal barrier. Materials along the crash route also burned, but probably at a much lower rate.

Figure 6: An inner cross section of the Twin Tower around the airplane after the aircraft has come to a stop. A simplified sketch of the fragmented aircraft (grey and black), a fuel tank with petrol (yellow and green, T), walls (brown) and the furniture (violet). The airplane is presumed to have formed a kind of bowl. Everything is on fire immediately after the crash.

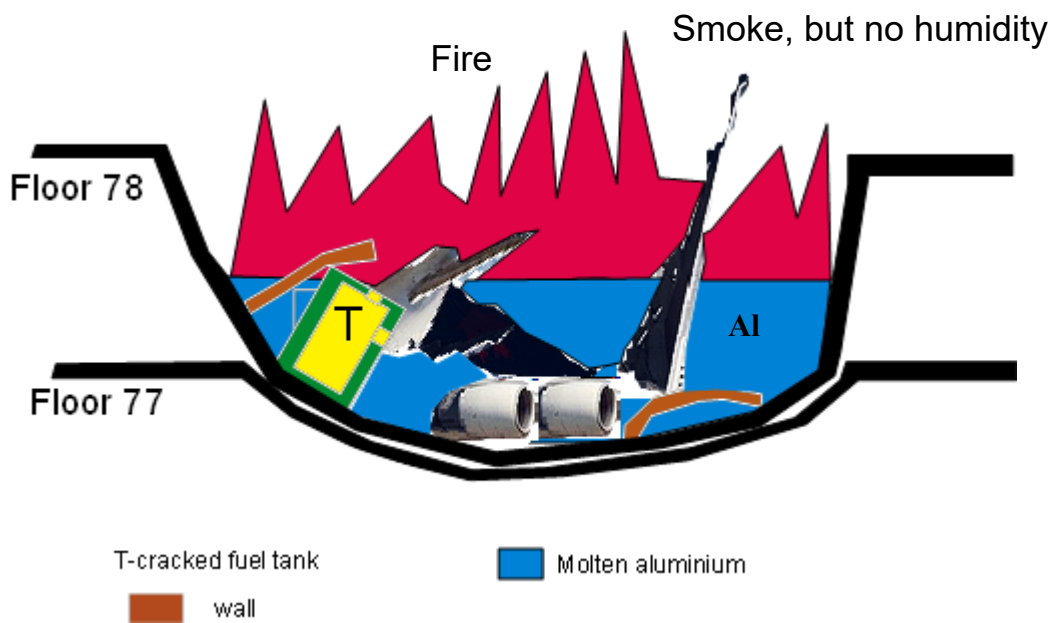
Figure 8
 Drawing of the remains of the fragmented airplane after the aluminium has melted. The temperature is approximately 700 °C.

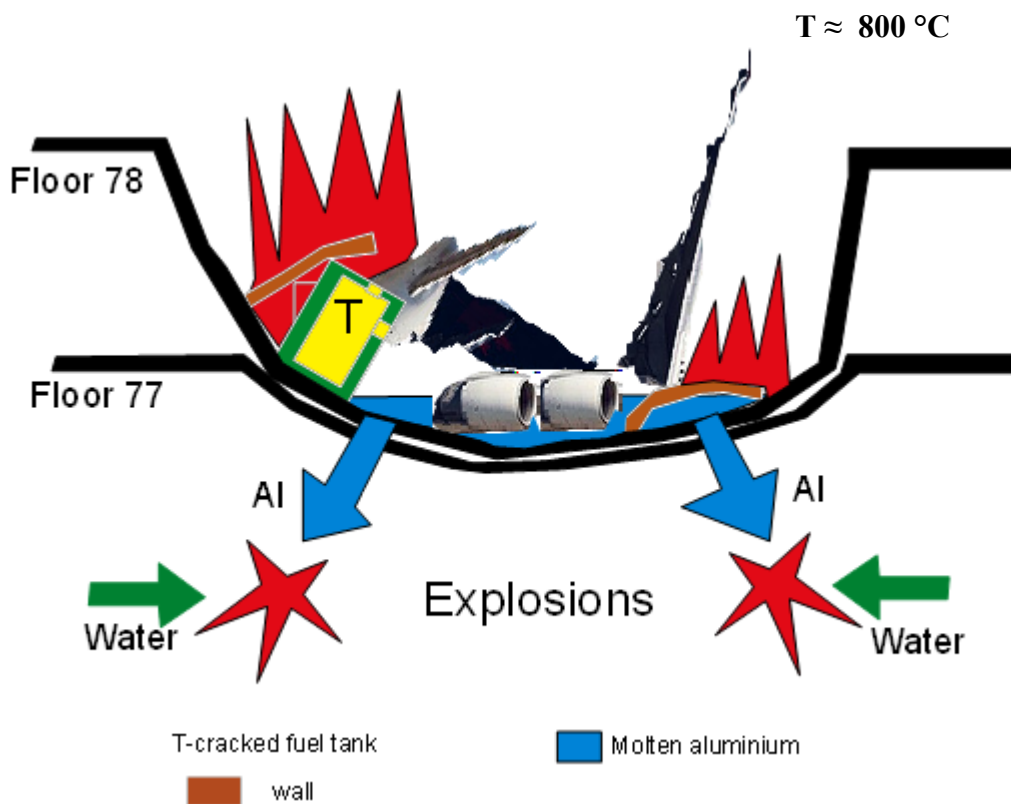
increased to 750-800 °C, the melt has so much surplus heat that it will flow freely in large streams to the floors below as illustrated on figure 9.

All water above the heated airplane zone would have evaporated due to the intense heating, while the floors below would be mostly unaffected by the crash. When the hot molten aluminium streamed to the lower floors, it would meet water generated from sprinkler devices (figure 9). These devices were installed in all floors of the Twin Towers. Several tonnes of aluminium would meet a smaller amount of water which supposedly should extinguish fires. The result would be fierce explosions between molten aluminium and water.

Figure 9
 Drawing of the fragmented airplane in the bowl when molten aluminium was flowing through the floor meeting water from the sprinkler devices and causing explosions.

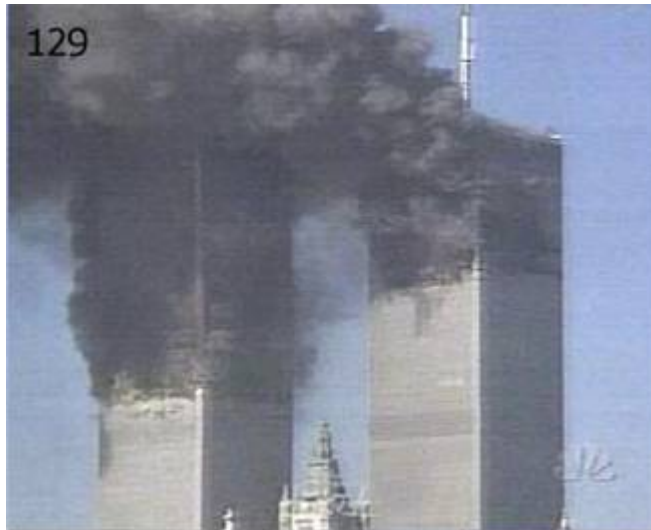
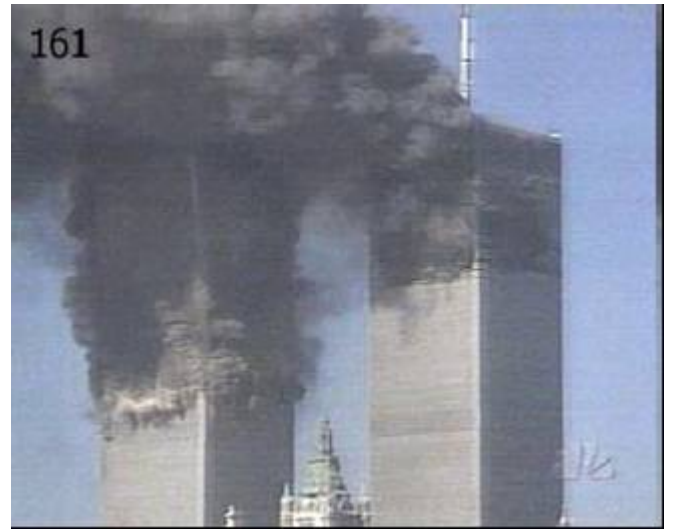
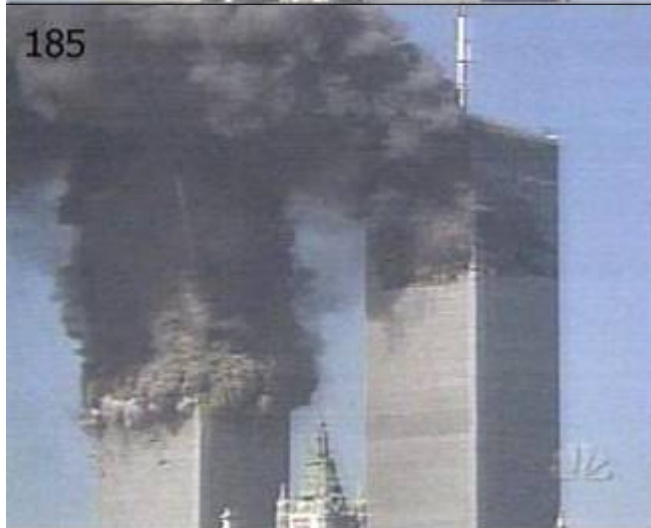
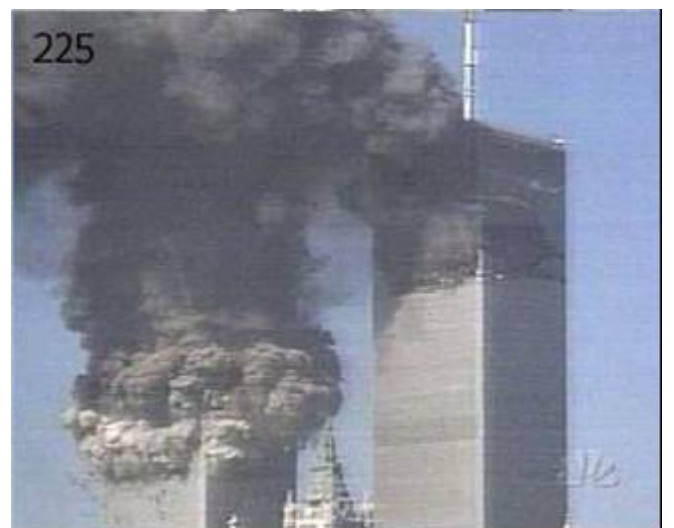
Many people in New York reported that they had heard explosions immediately before the collapse of the buildings. Pictures of the Twin Towers immediately before the collapse are shown in figure 10 and 11^{12,13}. These pictures are selected from two series taken at 8 frames per second. They show that the explosions take place on the floors below the floors with the fragmented airplanes. Vapour of a different colour came out of the windows indicating that a steam explosion had taken place (figure 10)). The second group of pictures, figure 11, show fast moving spikes of fire leaving the building. These pictures clearly indicate that explosions must have taken place in the interior. Furthermore, filmstrips taken of WTC 2 immediately before its collapse, show molten metal flowing out of a window down the wall¹⁴. This metal is aluminium as it is the only metal present in large quantities and has a low melting point. The colour of the melt is bright yellow indicating that the temperature of the melt is above 800 °C

Figure 10: Pictures of WTC 2 at the time of collapse, showing frame numbers taken at 8 frames per second. There are 12 sec from the first to the last picture. Note the grey smoke coming from the floors below the initial fire.

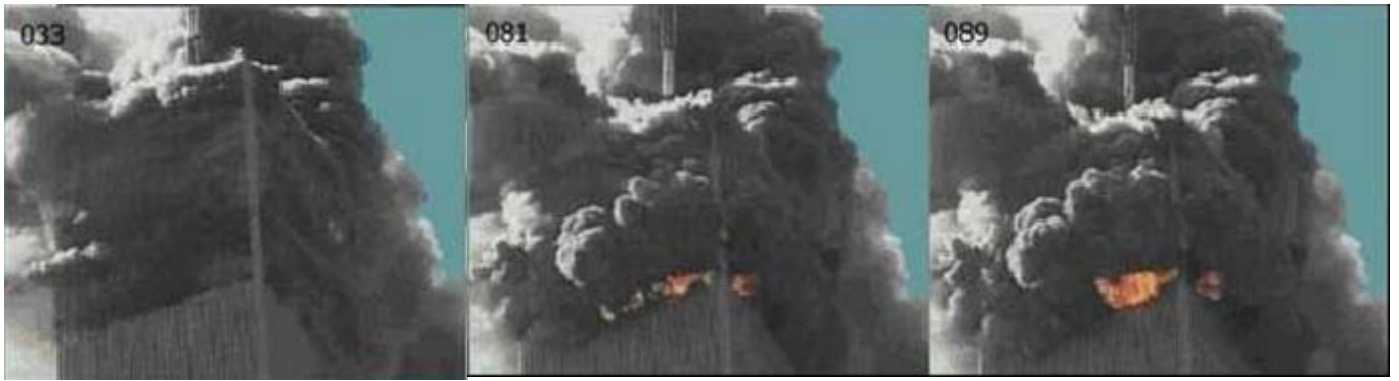
Figure 11
 Pictures of WTC 1 at the time of collapse, showing frame numbers taken at 8 frames per second. It is 7 sec from the first to the last picture. Note the red fire spikes coming from the floors below the initial fire.

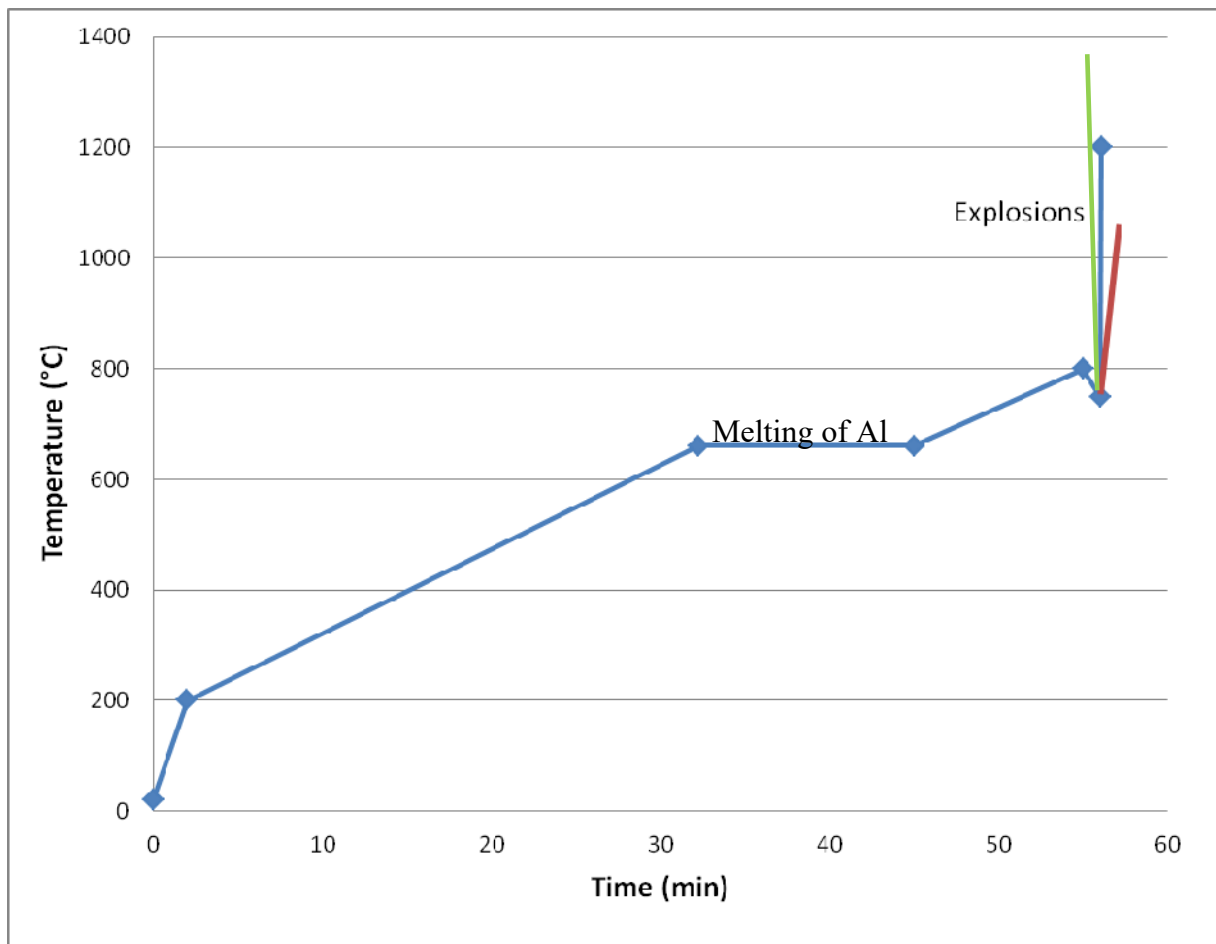
where the 3 minutes is the initial heating period plus 1 minute from the moment the melt is streaming down to the next floor to the time of explosions. If we assume this simple model, the temperature of the aluminium in the airplane in WTC2 is approximately as outlined in figure 12 where the collapse took place 56 minutes after the crash. The time schedule for the airplane in WTC1 is somewhat slower, 102 minutes between crash and time of collapse, most likely due to the fact that the airplane had a lower impact velocity and did less damage.

Figure 12: Temperature of aluminium in the airplane in WTC 2 in the period between the crash ($t=0$) and the collapse of the building ($t= 56$ minutes). The temperature decreases slightly when the melt leaves the hot zone and flows down to the lower floor ($t \approx 55$ minutes).

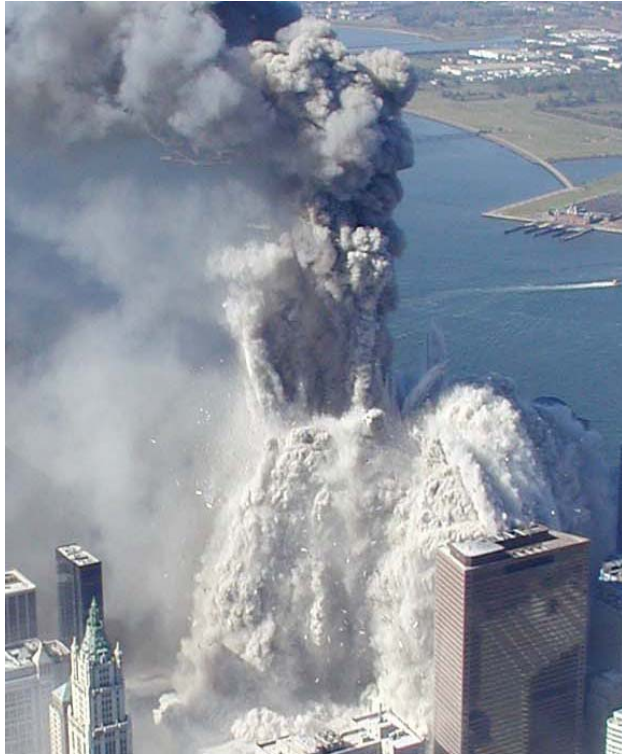
The outlined theory is in agreement with the observations made in New York on September 11th, and explosions took place as shown in the photo (figure 13¹⁷) of WTC 2 as the building collapsed. This model can be further verified by finding aluminium particles in the neighbouring buildings of the Twin Towers.

Figure 13: WTC 2 at the moment it collapses. WTC 7 is the building in front right. It is clearly hit by particles¹⁷.
