Organisation Glasgow Caledonian University

Title: Do Unprotected Small Diameter Service Penetrations in Fire Rated Constructions Hasten Gypsum Plasterboard Failure?

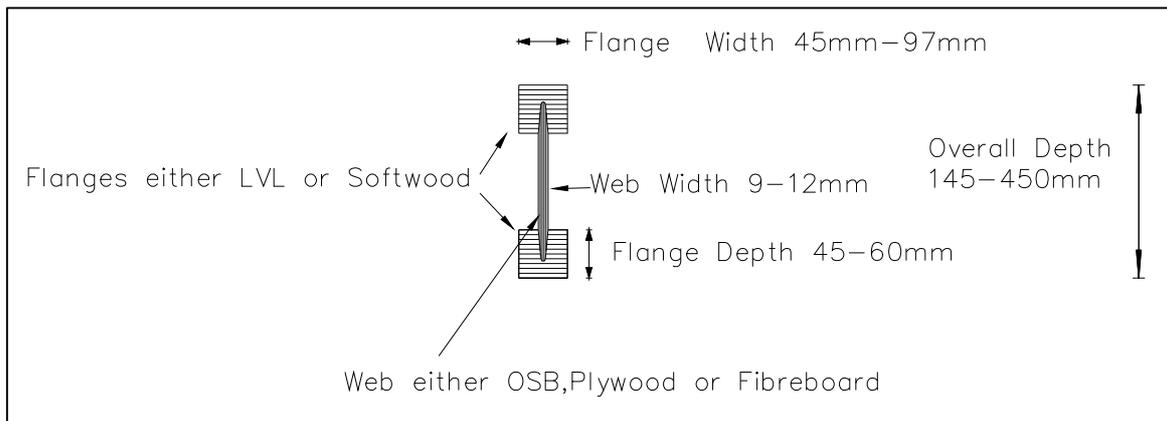
traditional rectangular timber sections, engineered timber products have become popular as they offer a number of benefits. Timber I-joists are one such product, which offer advantages such as: greater clear spans, which in turn offer design flexibility and construction economies; economy and sustainability in the use of forest products; structural economy, and construction economy as a result of lighter weight and improved performance in service [4][5]. I-joists are formed from rectangular softwood or Laminated Veneered Lumber (LVL) flanges, joined by a 9.5- 12mm thick web, which is commonly manufactured from Oriented Strand Board (OSB) (See Figure 1).

Figure 1: Section through an I-Joist

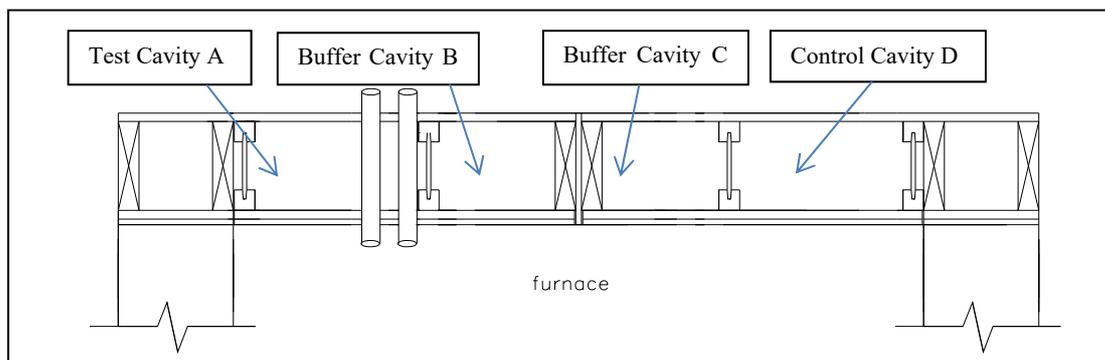
The floor sample consisted of 18 mm flooring grade particle board on 195 x 45 mm timber I-joists at 400 mm centres. The I-joists comprised 45 mm x 47 mm softwood flanges at the top and bottom, connected to each other by a 9 mm thick OSB web. The underside of the I-joists was lined with a base layer of 19 mm gypsum wallboard and a further layer of 12.5 mm gypsum wallboard. This specification was identified within an I-joint manufacturer’s technical manual as one providing 60 minutes fire resistance [15]. The samples contained both a construction cavity which was penetrated by plastic waste pipes and a control cavity with no penetrations (see Figure 2). In all cases the plastic pipe material used was Acrylonitrile Butadiene Styrene (ABS). The pipe penetrations were tightly fitted within the apertures in the particle board flooring and gypsum plasterboard. The minimal annular space around the pipe penetrations remaining were then sealed with inert gypsum based plaster filler; this type of fire-stopping material being permissible in the guidance to the Building Regulations.

Figure 2: Section through Floor Sample

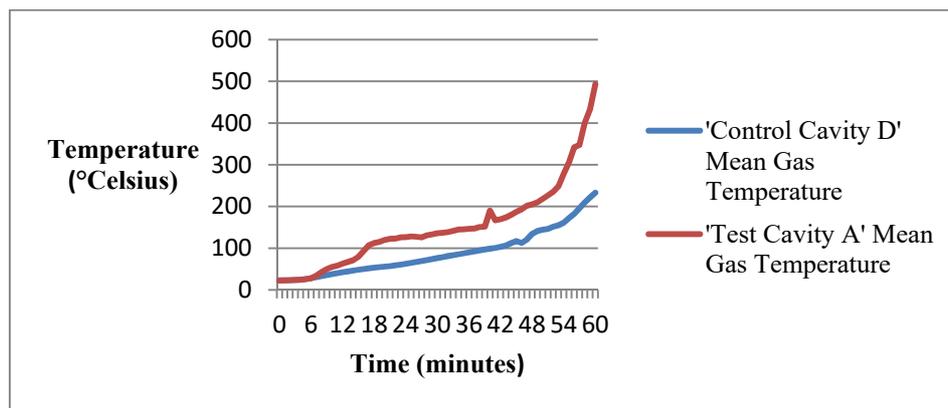
Test 1 had a pipe configuration which followed the guidance to the Scottish Building Regulations. Figure 3 shows that after 6 minutes the test cavity average gas temperature was consistently higher than the control cavity temperature, suggesting that the pipe penetrations did lead to increased temperatures within the construction cavity.

Figure 3: Mean Gas Temperatures 'Test Cavity A' and 'Control Cavity D'

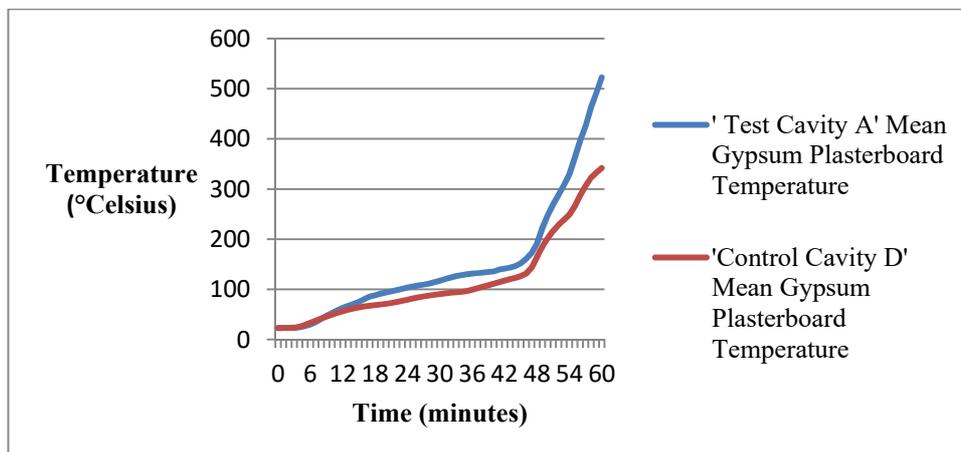
Figure 4 indicates that after about 12 minutes the test cavity's mean gypsum plasterboard temperature was consistently above that in the control cavity, suggesting that the inclusion of the pipe penetrations did lead to additional heating of the rear of the gypsum plasterboard.

Figure 4: Mean Gypsum Plasterboard Temperatures 'Test Cavity A' and 'Control Cavity D'

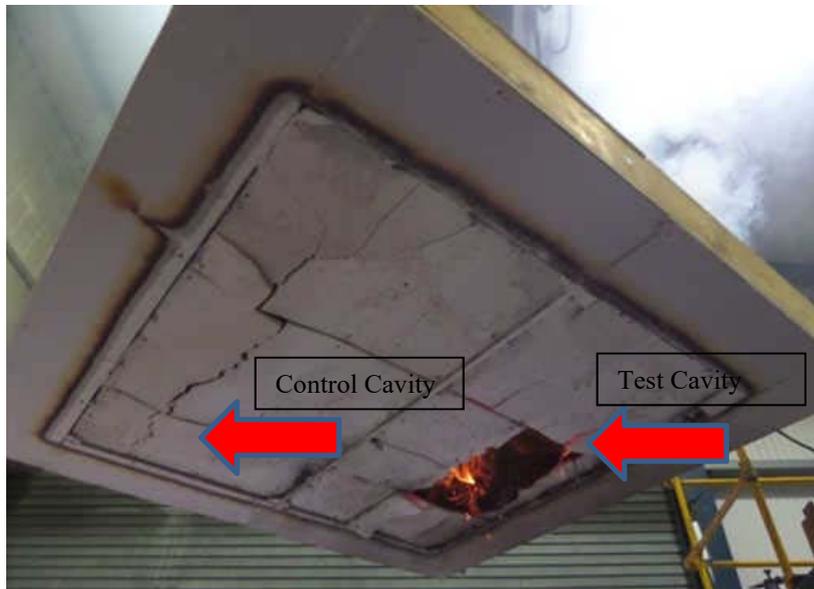
to each other, led to particular stress concentrations in the gypsum plasterboard. A larger piece of this gypsum plasterboard fell from the sample prior to the termination of the test, forming a larger hole. This can be seen in Figure 5 as the sample was being lifted from the furnace.

Figure 5: Test 1 Floor Sample being lifted from Furnace

By visual observation through the furnace window, after approximately 30 minutes the first layer of 12.5 mm gypsum plasterboard had predominantly fallen off; thereafter cracks appeared in the 19 mm inner layer of gypsum plasterboard. The inner layer of gypsum plasterboard to 'Test Cavity A' failed to a greater extent than the inner layer gypsum plasterboard to 'Control Cavity D'. It appeared that cracks eventually connected the apertures for the pipe penetrations to each other and to other cracks and a single larger hole developed. It seems probable that the proximity of the 40 mm diameter apertures for the pipe penetrations

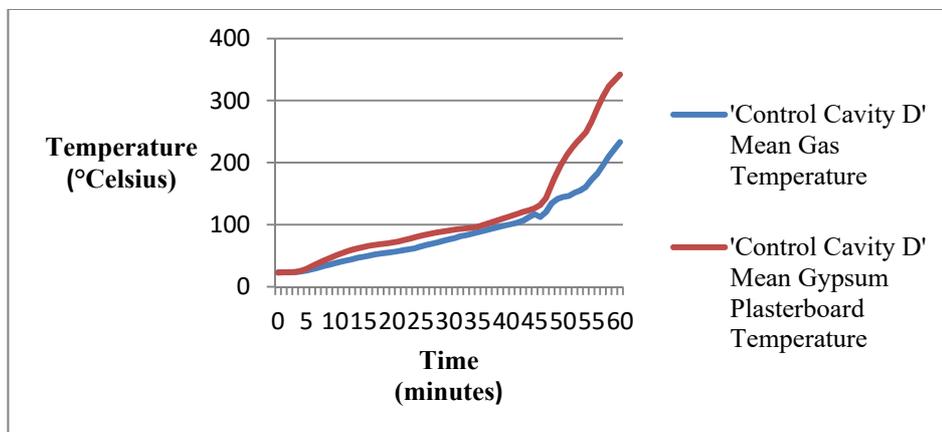
It can be seen from Figure 6 that the mean gypsum plasterboard temperature in 'Control Cavity D' was consistently higher than the mean gas temperature; presumably due to conductive heat transfer through the gypsum plasterboard.

Figure 6: Mean Gas/Gypsum Plasterboard Temperatures 'Control Cavity D'

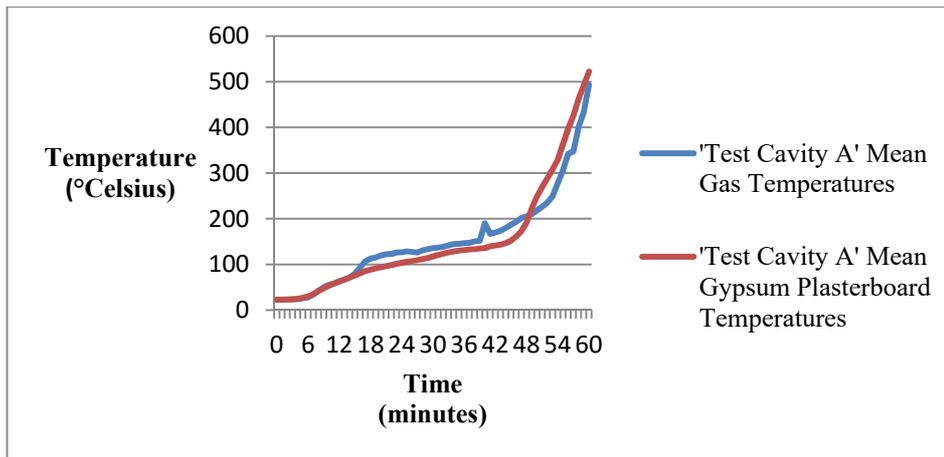
Figure 7: Mean Gas/Gypsum Plasterboard Temperatures in 'Test Cavity A'

In 'Test Cavity A', for part of the test period the converse was true, which can be seen in Figure 7. This reversed towards the end of the test period when the gypsum plasterboard temperature exceeded the gas temperature, which approximates with the time that cracks between the penetration apertures joined, forming one larger hole in the inner layer of 19 mm gypsum plasterboard.
